# Manawatū Estuary

## 2021/2022 intertidal sediment monitoring summary

April 2022

Salt Ecology Short Report 011. Prepared by Leigh Stevens for Horizons Regional Council, April 2022.

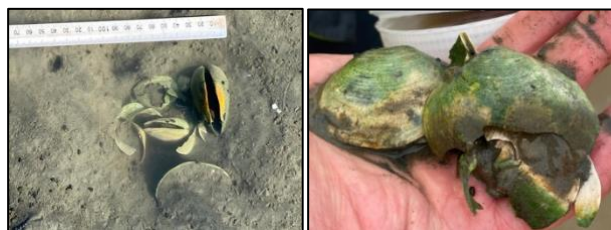
These findings are supported by field observations, showing shellfish beds that have been uncovered by scouring and are visible on the sediment surface (see photos below). The erosion observed across the tidal flats of Manawātū Estuary is likely a consequence of scouring during high river flows in the Manawātū River.

Previously buried shells uncovered by recent scouring at Site A.

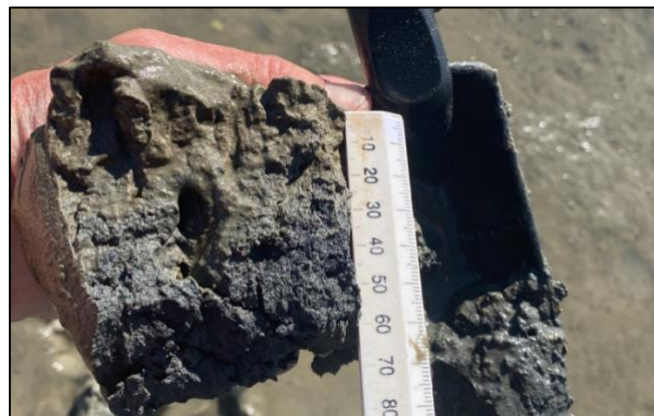
The aRPD depth was 35mm at Site A in Jan-2022, and 20mm at Site B (Table 2). These values correspond to a condition rating of 'good'. This level of oxygenation is likely to be partially maintained by the presence of crabs and burrowing organisms in the surface sediments, which turn over surface sediments and create voids that allow air and water to transfer oxygen to underlying sediments.

Example of well-oxygenated sediment at Site A.
